GEOTECHNICAL INVESTIGATION REPORT FOR THE PROPOSED YOUTH DEVELOPMENT CENTRE AT MANDENI, KWAZULU-NATAL.

BD 1347/REV 01

30 JULY 2019

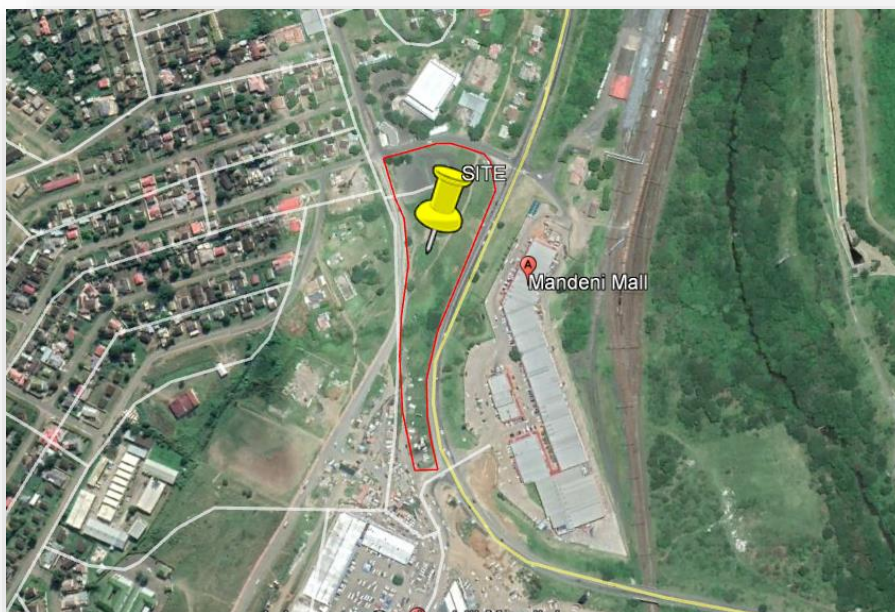
Figure 1: Aerial view of the site.

The study area is located at Mandeni, KwaZulu-Natal. The site may be located using the following central coordinates 29°08'32.45"S and 31°24'11.92"E. The proposed site is approximately 70m west of Mandeni Mall (Figure 1).

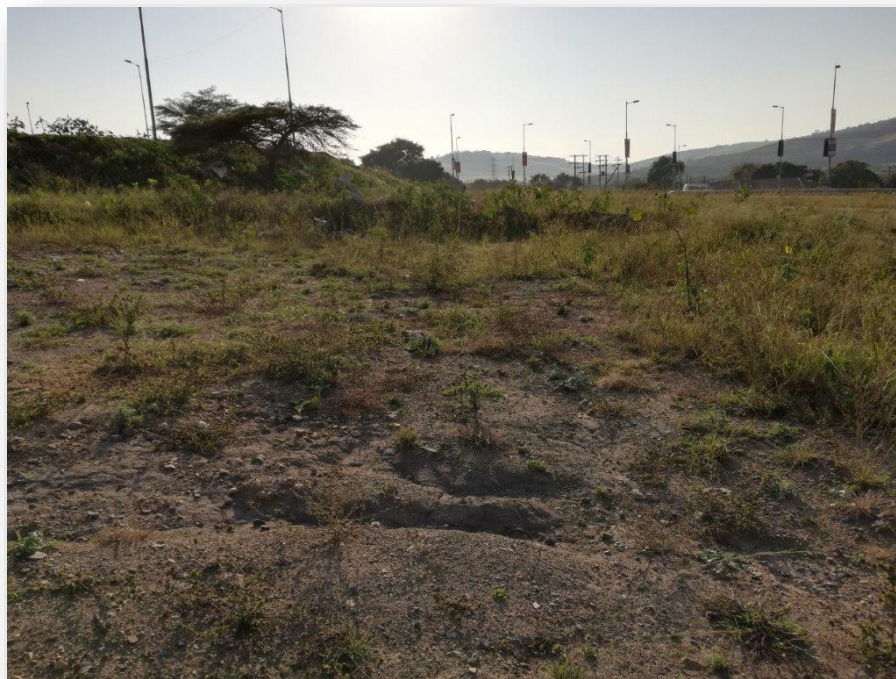
Figure 3: Site at the time of the investigation.

At the time of the investigation, there were no existing structures on site. A marker post showing an existing Transnet pipe line was noted on the eastern flank of the site.

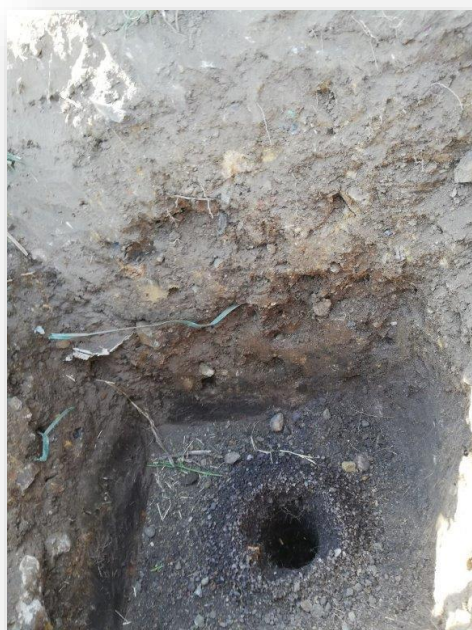
Figure 5: Fill retrieved from a test pit.

Fill material was noted in the upper profile of TP1, TP3, TP4 and TP5. It was noted that the layer of uncontrolled fill extended from ground level down to a maximum depth of 0.90m (TP4). In general the horizon was described as moist, brown mottled yellowish orange, dense, silty SAND with rootlets, plastic, cloth and builder's rubble.

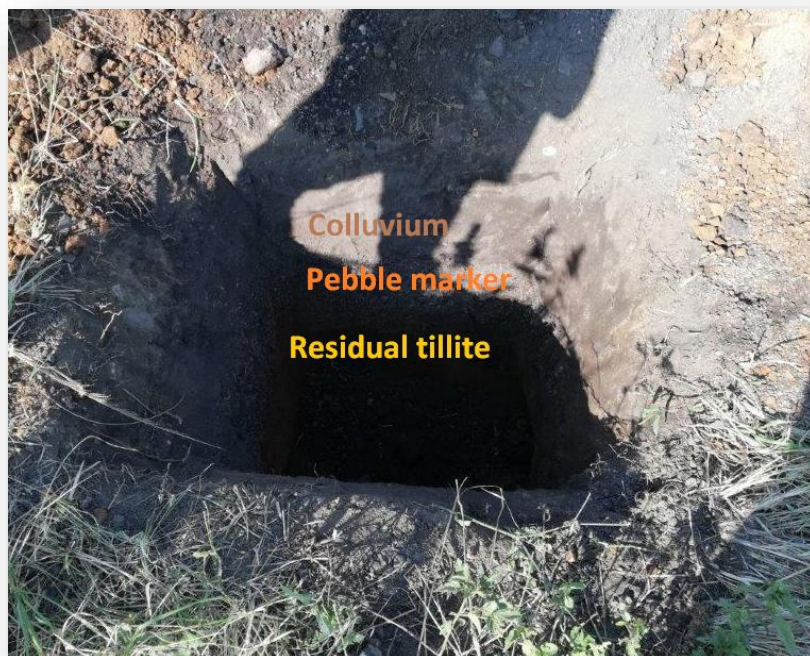
Figure 6: Typical test pit showing subsoil profile.

Figure 6 above shows the various soil horizons encountered on site. The layer of residual tillite is overlain by a pebble marker horizon, and the pebble marker horizon layer is overlain by a layer of colluvium material.

A layer of pebble marker was noted in TP2 and TP4, the layer extended between from a minimum depth of 0.60m down to a maximum depth of 1.30m. This layer was described as abundant (>50%) angular to subangular gravel tightly compacted in a matrix of moist, brown, loose, silty SAND. The layer of pebble marker indicates the transition between residual and transported material.

A layer of residual tillite was noted at the base of TP1, TP2 and TP5. The layer extended from 0.45m down to 1.20m below existing ground level. This layer was typically described as very moist, orange stained black, medium dense, slightly clayey SAND.

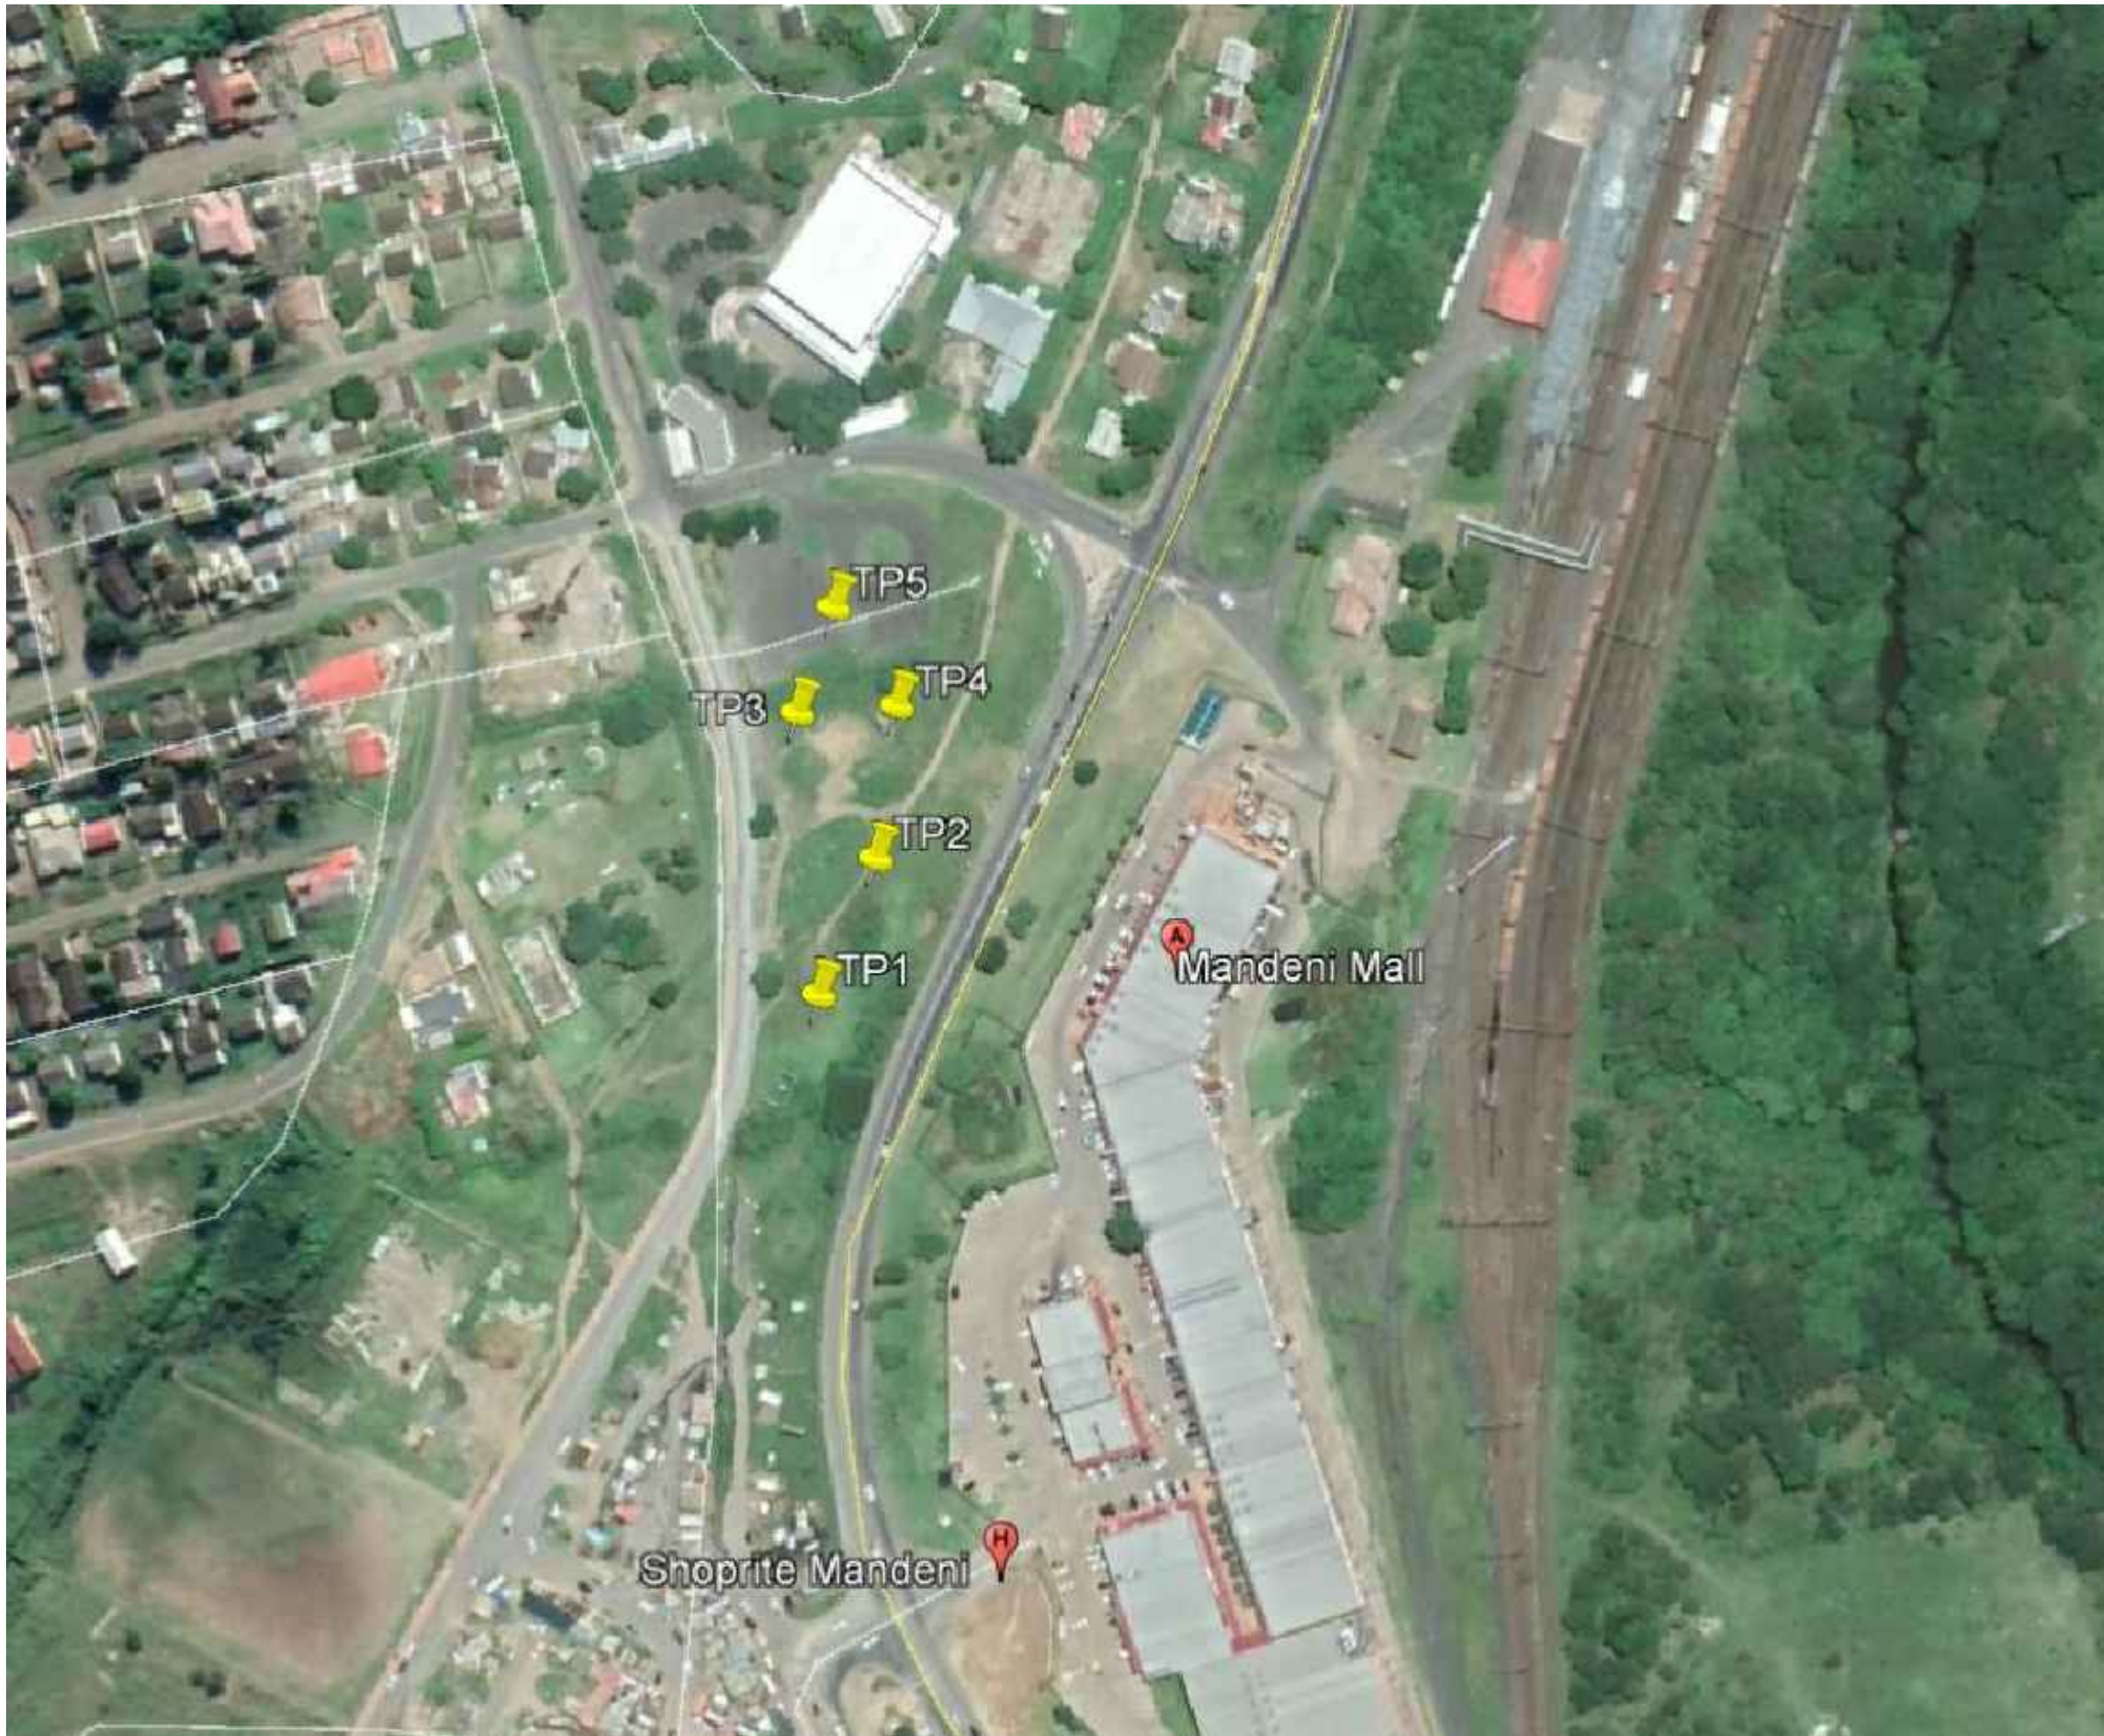
PROJECT NUMBER DRAWING NUMBER STATUS REVISION
 BD-1347-GE-001-R-00

TEST POSITIONS – BD-1347-GE-001-R-00

A total of Five (5) Dynamic Penetrometer Light (DPL) tests were undertaken adjacent to the test pits. The results of the DPL tests were used to evaluate the consistency of the underlying material and the depth of refusal on the underlying material. The DPL tests across the site provided information on the in situ relative densities of the subsoil down to a maximum depth of 2.1m below EGL. At each test position, the GPS coordinates of the positions were recorded. The results are summarised and included in Appendix B and C at the end of this report. The test positions are shown on Drawing No BD-1347-GE-001-R-00 in Appendix A.

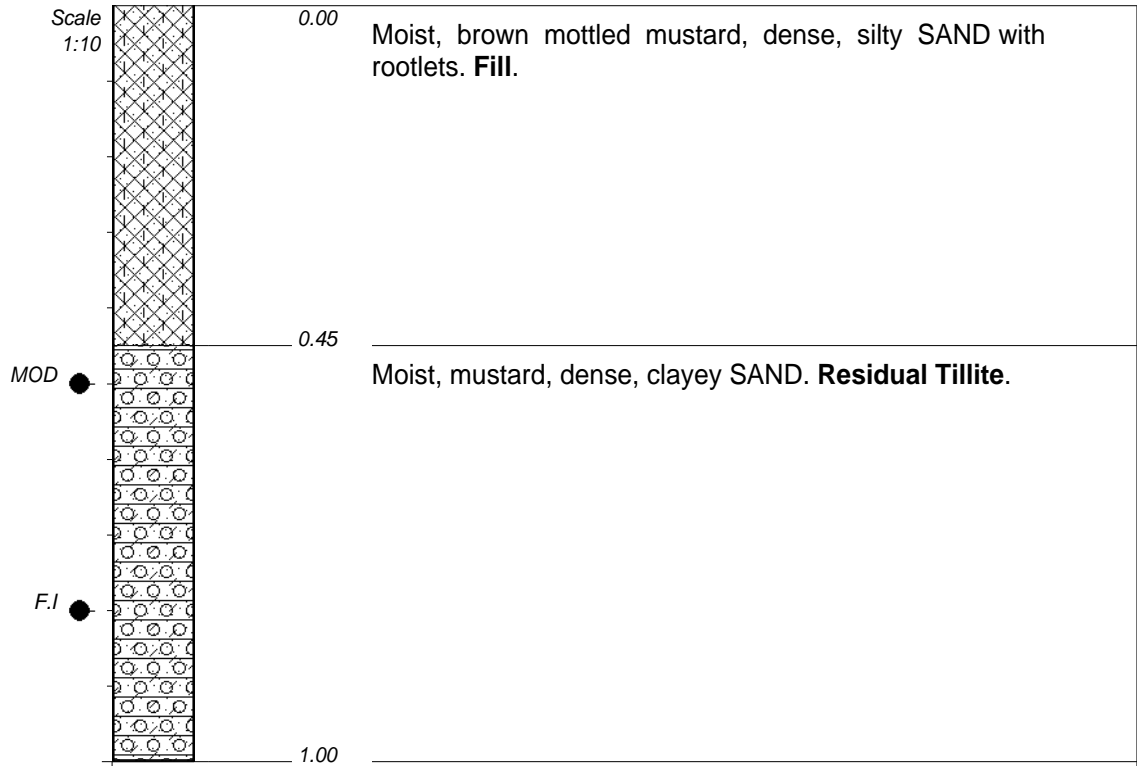
HOLE No: TP 05
Sheet 1 of 1

- NOTES**
- 1) MOD CBR sample taken @ 0.5m-1.0m
 - 2) F.I sample taken @ 0.8m-1.00m

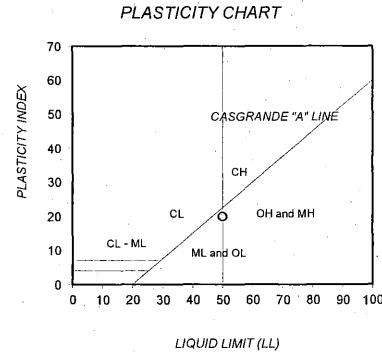
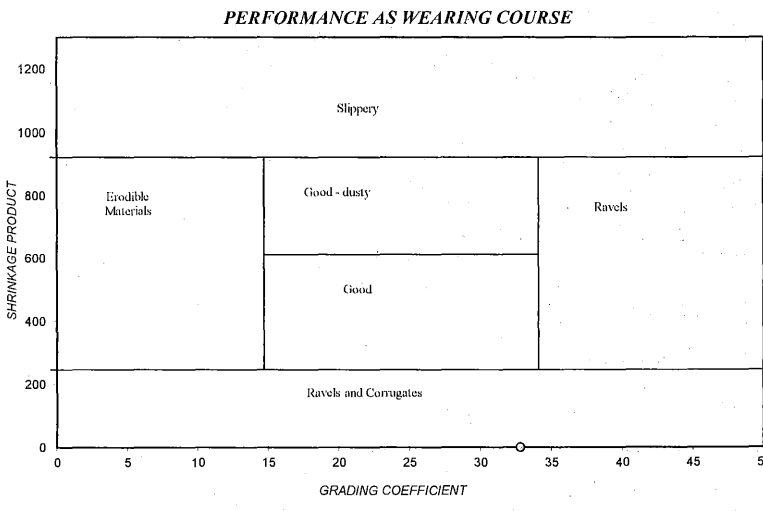
FOUNDATION INDICATOR RESULTS (SANS 3001 - GR1,GR10,GR11,GR20 & #SANS 3001 GR 3:2014)

Weighted PI		10.5
Sieve analysis Cumulative percentage passing (mm)	75.0	100
	63.0	100
	53.0	100
	37.5	100
	28.0	100
	20.0	100
	14.0	100
	5.00	91
	2.000	64
	0.425	53
	0.250	49
	0.150	44
0.075	38	
0.050*	18	
0.005*	16	
0.002*	12.4

Soil Mortar Analysis % < 2.00mm	2.000 - 0.425	18
	0.425 - 0.250	6
	0.250 - 0.150	7
	0.150 - 0.075	9
	< 0.075	60
Effective size	0.002	
Uniformity Coefficient	727.6	
Curvature Coefficient	1.4	
Oversize Index	0.0	
Shrinkage Product	0.0	
Grading Coefficient	32.8	
Grading modulus	1.46	
Ater-beg Limits	Liquid Limit	50
	Plasticity Index	20
	Linear Shrinkage	10.0
	PI < 0.075	
Unified Soil Classification		SC
U.S. Highway Classification		A-7-6
#pH - Value		N/A
Moisture Content		N/A
Compactibility Factor		N/A
#Conductivity mS/cm		N/A

CLAY (%) (0.001-0.002)	SILT (%) (0.002-0.060)	SAND (%) (0.060-2.00)	GRAVEL (%) (2.00-60.0)
12.4	25.6	25.9	36.1
