Vuthela iLembe Municipality

## VILP/I/036 - Vuthela iLembe LED Programme

Sundumbili Water Treatment Works:  
Improving Energy Management and  
Efficiencies

Reference: IDM-01

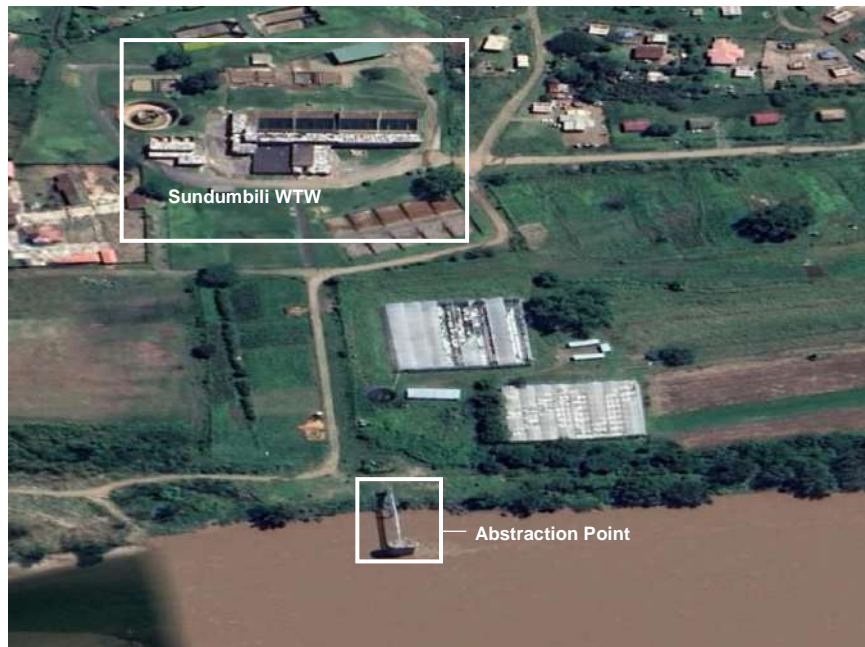
Figure 1: Sundumbili WTW plant layout (Source: Google Earth)

The Sundumbili WTW site is approximately 2.6 hectares, of which an estimated 1.4 hectares are occupied by the WTWs, buildings and ancillary components. See Figure 1 on the next page for the site overview. According to the August 2020 State of Municipal Water, Sanitation and Electrical Infrastructure study conducted by LTE Consulting, the Sundumbili WTWs was listed to be in poor condition, requiring extensive refurbishment. From the site visit assessment undertaken in June 2022, we can confirm that this is still the case for the older parts of the plant.

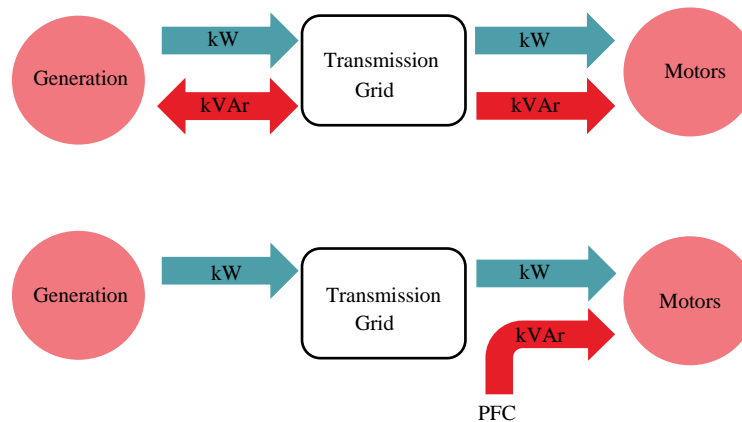
Figure 3: Power Factor Correction [6]

The purpose of PFC is to reduce excessive reactive power drawn from the utility network as it has the capability of producing reactive energy in opposition to the reactive power absorbed by loads such as motors. This in turn reduces the overall demand charge on apparent power or kVA which leads to improved energy efficiency and a reduction to the plant's consumption bill. Figure 3 explains the flow of power with and without PFC.

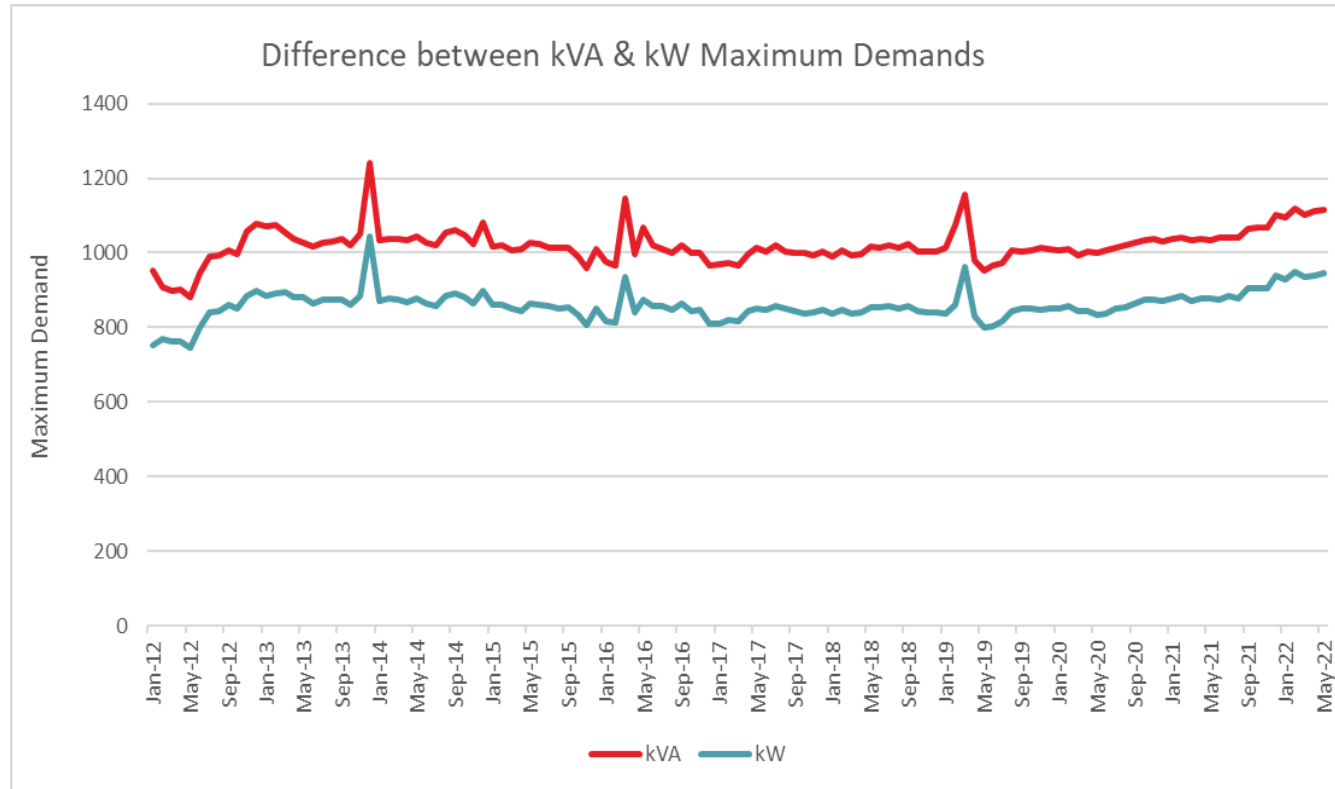
**Figure 4: Graph showing difference between maximum kVA & kW for the Sundumbili WTW**

Figure 4 below, shows the combined maximum demands of both the internal and raw water works and illustrates the difference between the maximum active power (kW) demand and the maximum apparent power (kVA) demand with the highest difference being ~213kVA. This is due to the fact that reactive energy is drawn by the motors from the grid which thus raises the maximum kVA since kVA is a combination of active (kW) and reactive power (kVAr).

If the PFC was operational this would eliminate or reduce the reactive power drawn from the grid by the motors, by raising the power factor closer to unity at the point of connection, thus bringing the kVA demand closer to the kW demand resulting in a lower kVA demand charge. In addition, a saving on reactive energy (kVAr) charges will be achieved. The plant's raw water works is currently being charged at a rate of R31.96/kVA during the low demand season and R248.38/kVA during the high demand season. There is also a network demand charge of R49.98 based on the maximum kVA demand reached. This equates to a combined charge on maximum demand (kVA) of roughly R326,821 per year. This cost can be reduced by approximately 14% (assuming unity power factor after correction) if the PFC system was operational as this is the average difference in kVA and kW demand for the raw water works from 2020 to 2022. The Miniflex tariff charges a single demand charge of R34.60 based on the NMD and this results in total demand cost of R174,697 per year for a 400 kVA NMD (raw water works NMD) which is a much lower demand cost. It is also important to note that the raw water works is the only plant section with these charges as it is on the Nightsave Urban Small tariff. Thus, as mentioned in the section above, it may be beneficial to change the raw water works tariff to the Miniflex tariff as well.

It is thus recommended that the plant’s PFC be repaired/renewed. The average power factor for the internal water works is currently 0.769 p.u. and 0.860 p.u. for the raw water works (determined from the plant’s 2022 consumption data) which are relatively poor power factors. An alternative to repairing the PFC is that Variable Speed Drives (VSDs) could be installed on the motors to improve operating overall power factors and reduce load demand. The water pumps in the plant utilize IE3 induction motors which are fairly efficient. However, should any of the motors need replacing, Arup recommends that they be replaced with IE4 induction motors as these are slightly more efficient and have a higher operating power factor.

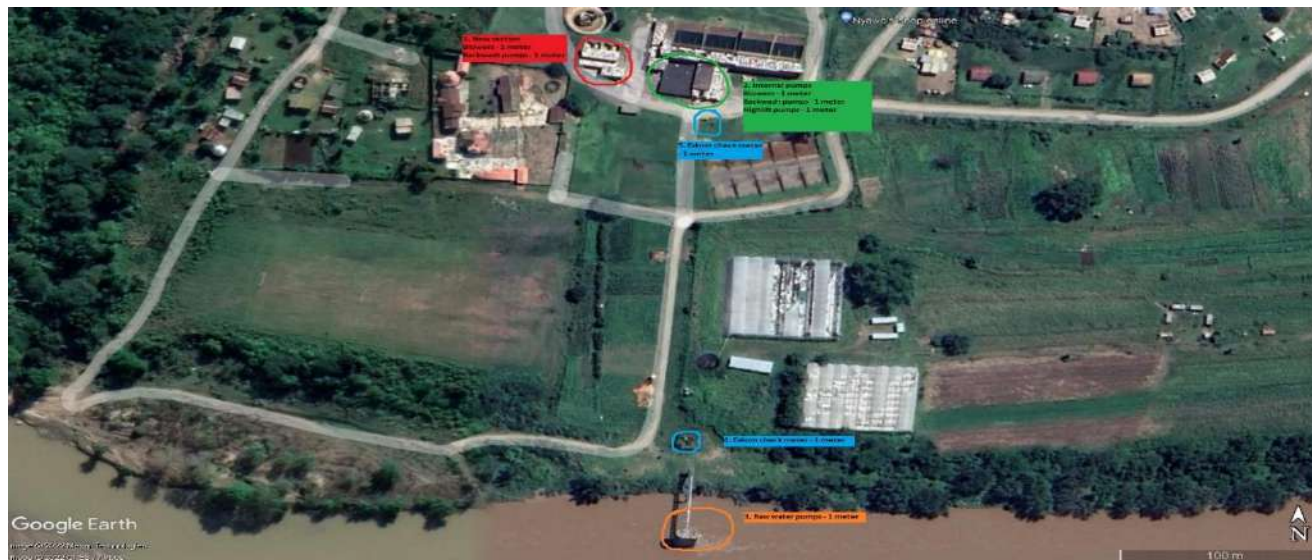
Figure 5: Metering Points

One of Arup's recommendations to improve and manage the plant's energy efficiency included the installation of digital meters. These meters would have the capability of measuring and storing consumption data which can be used to monitor and analyse the plants energy consumption as well as verify Eskom's consumption measurements and billing data. Electricity meter quotes were obtained from three different suppliers. Based on communication with the IDM team, a total of eight metering points were considered as critical to monitor, see Figure 5 and Table 6 for an overview of these points. A single line diagram (SLD) provided by IDM is attached in Appendix A1.4. It shows all the pumps that require metering and how they are connected to the two points of supply. Please note that this is a roughly drawn hand sketch as the actual SLD drawings for the plant could not be located. Arup recommends that an electrical engineer/technician be contracted to develop a SLD that includes all main equipment ratings (voltage, current and short-circuit ratings) and cables sizes so that it can be kept on site for future use.

Arup recommends using SEC Electricals services as they have a working relationship with the Sundumbili WTW plant and are closer to the plant than the other suppliers. SEC Electrical have also conducted a site inspection to determine their quote which makes it more accurate as it includes only the required items compared to IST's quote. SEC Electricals cost however, does not include power monitoring expert (PME) and server costs which could cost approximately **R 96,588.00** and **R134,652.00**, respectively. This would bring their total cost to **R 395,723.11**.

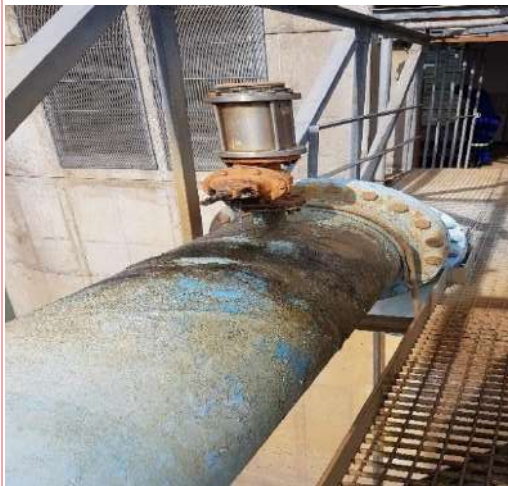
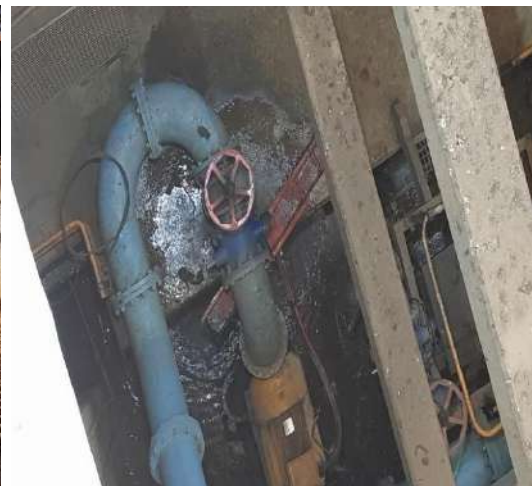
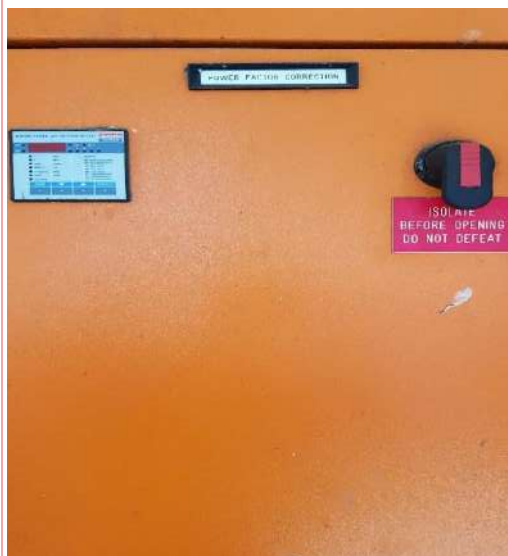
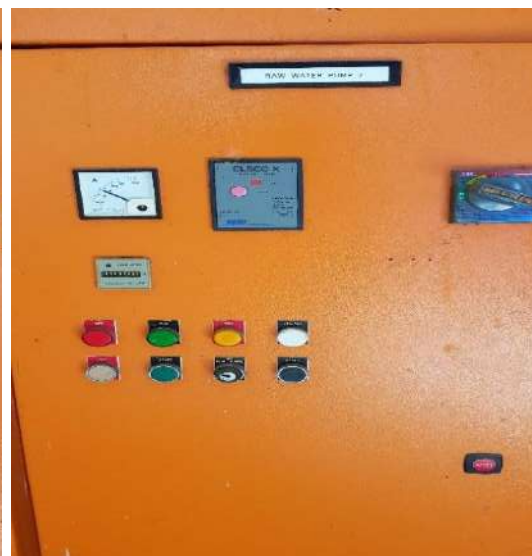
Area	Description	Site visit image
<p><b>Raw Water Pumps</b></p>	<p>Pumps used for raw water extraction rated at 90kW.</p> <p>Two pumps were operational with the standby pump removed for maintenance.</p> <p>Leaks were noted during inspection at the pump area as well as along the extraction piping. These leaks were due to valve and motor gland packings needing replacement.</p> <p>The power factor correction device was not working during the site visit. The Plant Operator indicated that it had operated for a long period.</p> <p>The meters for this section are analogue meters.</p>	  <p>The 'Site visit image' column contains four photographs. The top-left photo shows two blue pumps with pipes and a valve handle. The top-right photo shows a metal electrical panel mounted on a wall. The bottom-left photo shows a large yellow motor with a fan. The bottom-right photo shows a metal frame structure with a flat metal plate on top.</p>

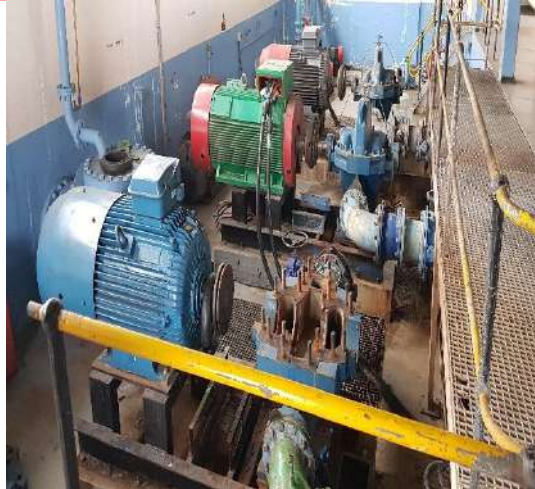
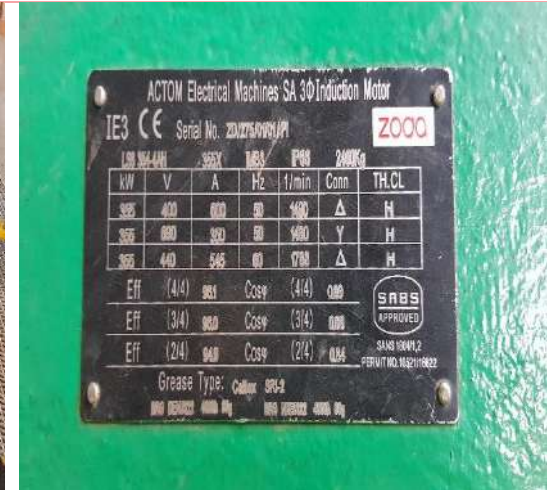
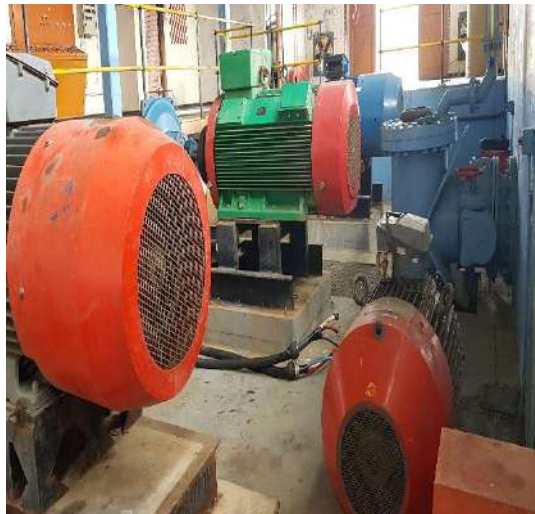
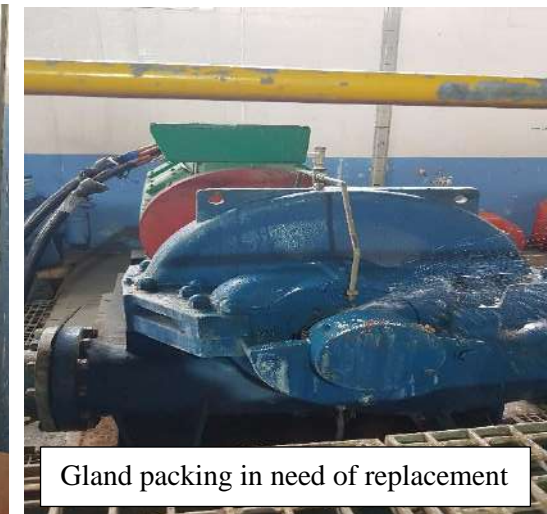
These are the pumps used for pumping water into the reservoirs once purification is completed. They are rated at 355kW. Two pumps were operational with the standby pump removed for maintenance. Leaks were noted during the inspection at the pump area. This may be due to the gland packings that needed replacement.

The power factor correction equipment was not operational as the equipment was damaged by a fire caused by a transformer explosion in the control room. The cause of this explosion is unknown, and a root cause analysis is currently being conducted. Moderate flooding is a result of the leakages occurring in this room. The Operator has noted that this has been fixed as a result of installing new gland packings on the motors and valves.

The soft starters for these motors are still functional. Soft-starters ramp up the voltage applied to motor terminals over time, thereby limiting the inrush current and power during start-up. Soft starters can thus extend motor lifetimes particularly for motors that are stopped and started frequently [8].

Replaced gland packing

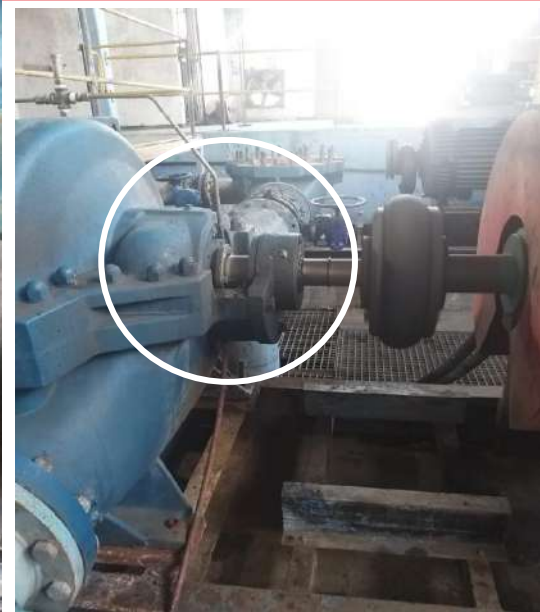
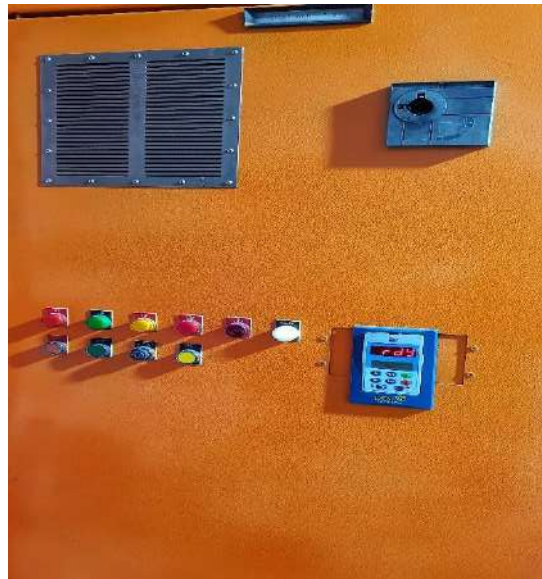
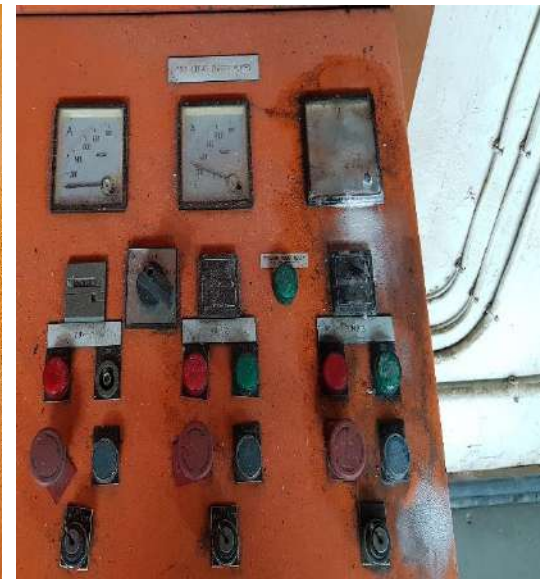
Water leakage due to gland packing needing replacement.

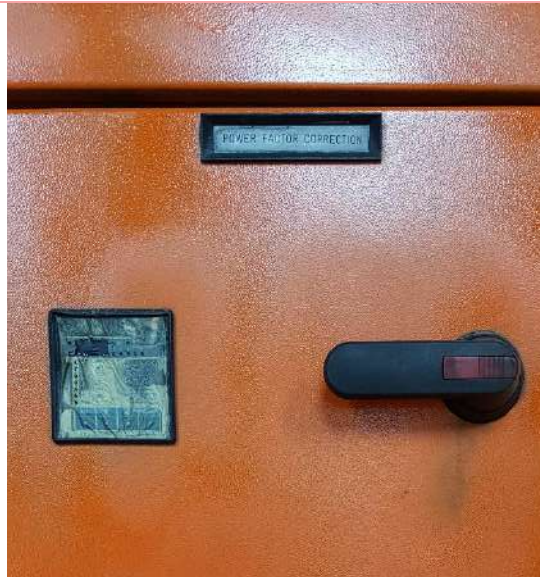
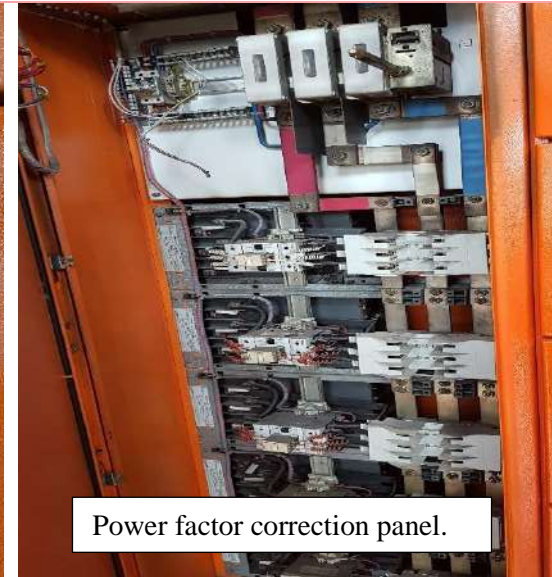
Power factor correction panel.

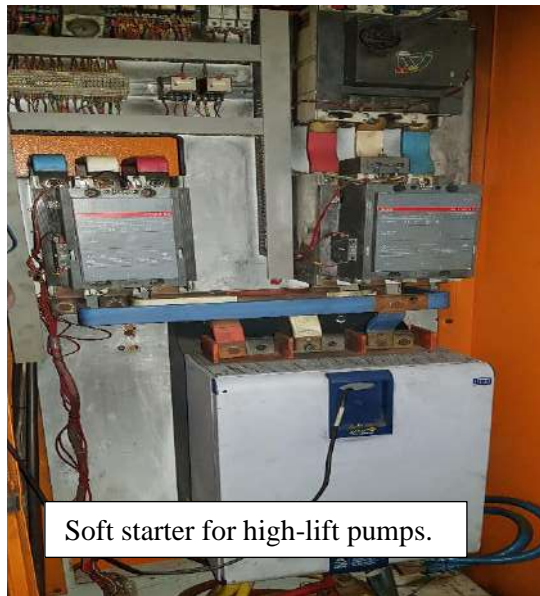
Soft starter for high-lift pumps.

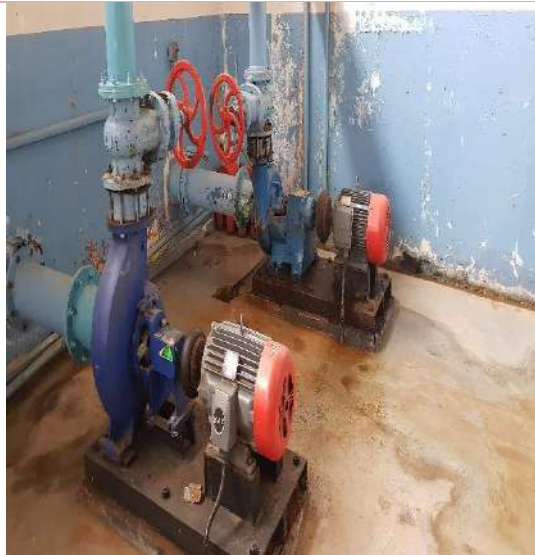
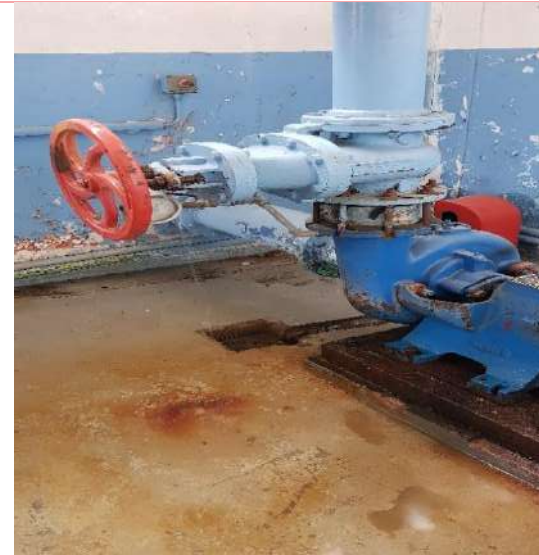
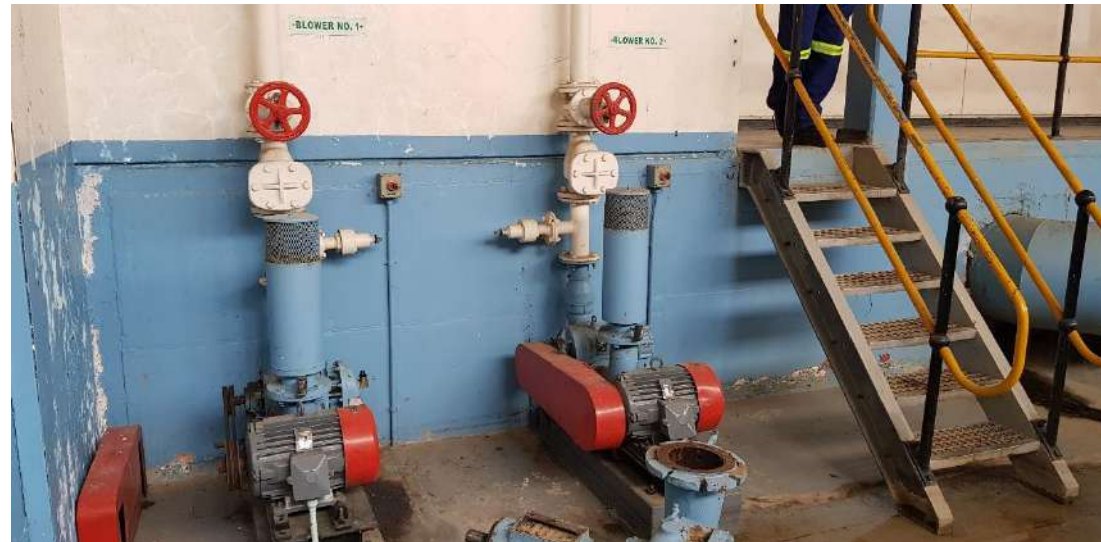
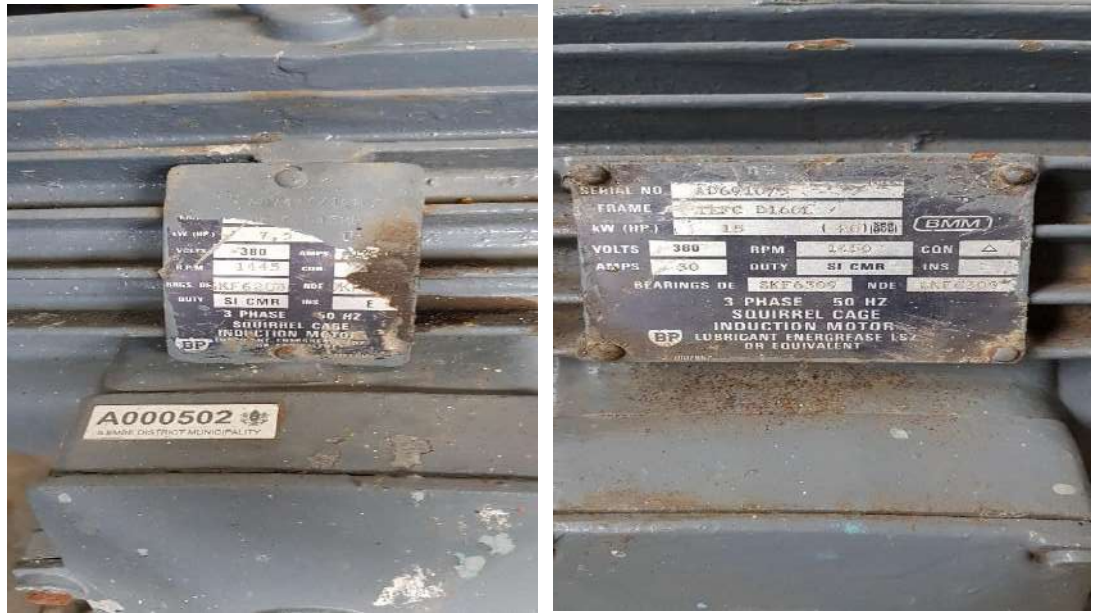
**Blowers and Backwash Pumps**

Pumps are used to clear debris from the internal water works. These pumps were in good condition and operating as usual. However, one of the backwash pumps has a leak due to needing a gland packing replacement. The panels for these pumps are in good condition.

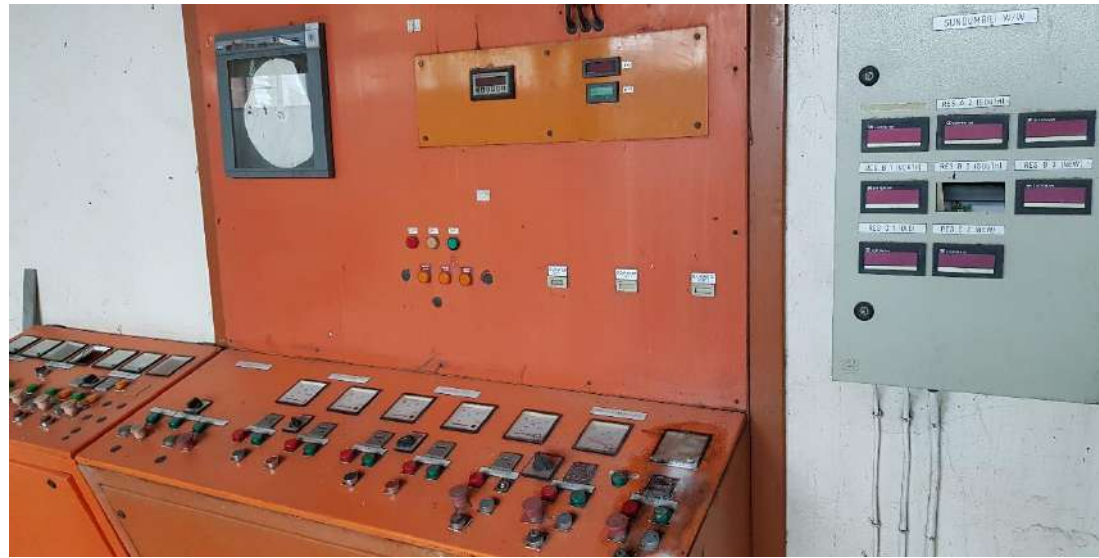
The control equipment in the high-lift room needs refurbishing and cleaning. Some of the panels are no longer functional. The controls on these panels can be replaced with digital meters and controls which would potentially improve energy management.

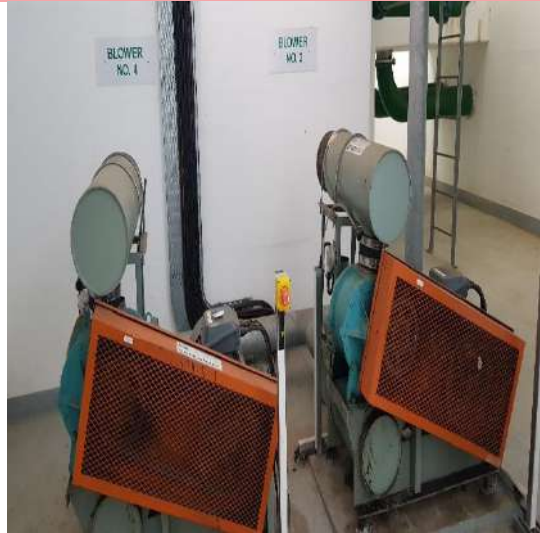
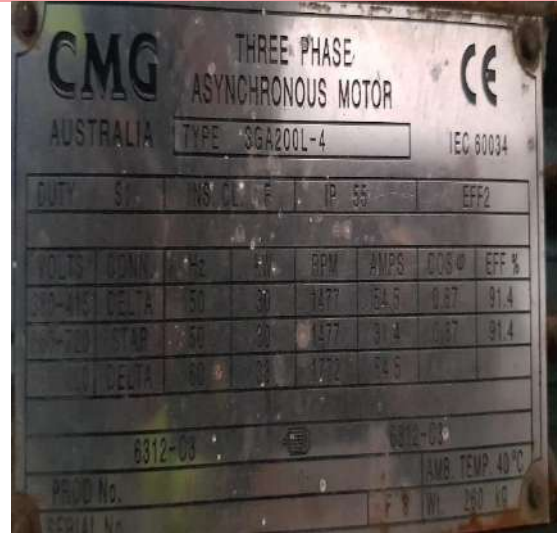
**Extended Plant Section**

This area contains blowers and backwash pumps rated at 30kW and 50kW, respectively. This section of the plant is fairly new and was constructed in 2011 to upgrade the plant's capacity. All electrical infrastructure is functional, and water loss was not noted in this section.

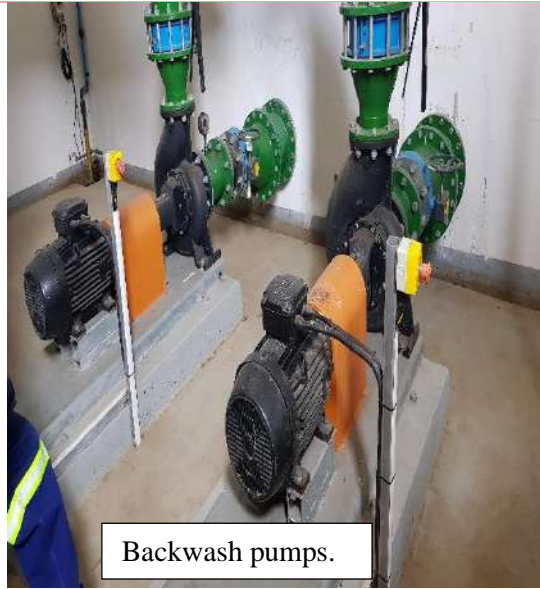
Backwash pumps.

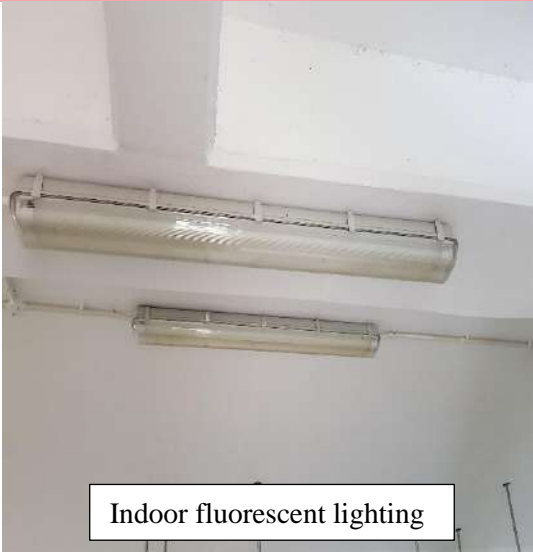
<p><b>Plant and Admin Building</b></p>	<p>The plant uses fluorescent lighting indoors and LED lighting outdoors. These lights are generally energy efficient with LED lighting being ~80% more efficient. The only major load consumer in the administrative building is the air-conditioner and the fridge which is generally rated energy efficient.</p> <p>The plants wiring is relatively in poor condition as seen on the images further below.</p>

<p style="text-align: center; border: 1px solid black; padding: 2px;">Indoor fluorescent lighting</p>

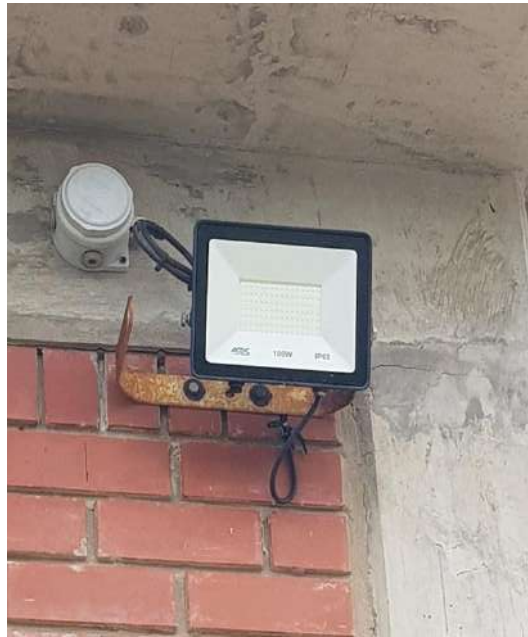
Outdoor LED lighting

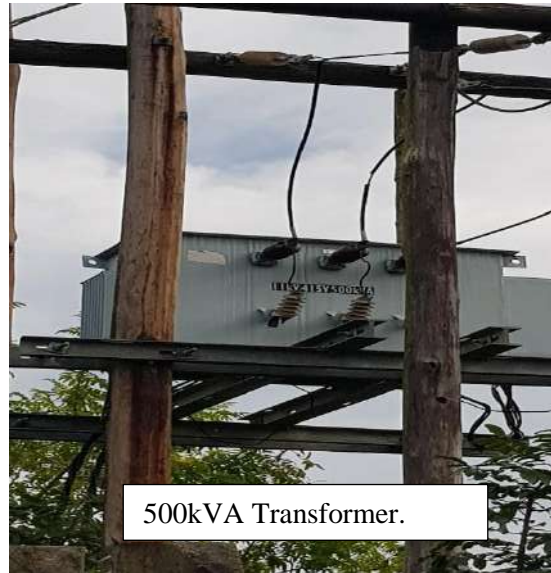
The transformers onsite are in good condition. A new 1,000kVA transformer was recently installed to replace the one that exploded and to cater for the increase in NMD. The meter cubicles were locked and there were no Eskom personnel on site to provide access.

500kVA Transformer.

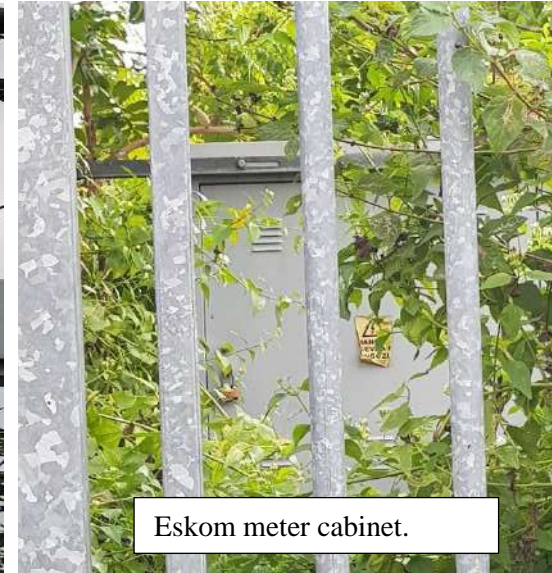
Eskom meter cabinet.

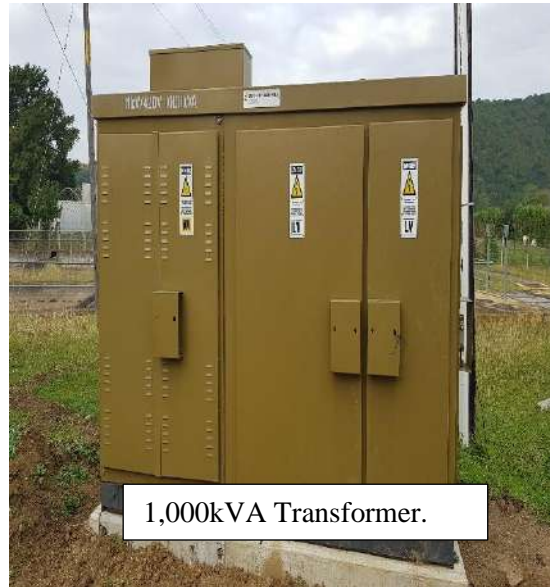
1,000kVA Transformer.

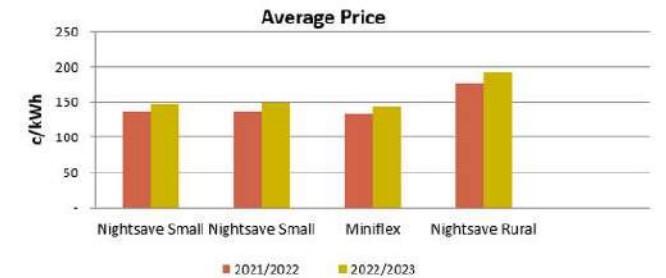
Figure 6: Eskom Tariff Analysis

The screenshots below detail Eskom's analysis of altering the raw water works tariff from the Nightsave Urban Small tariff to the Miniflex tariff. The final comparison of costs shows that a net saving of ~R61,175 (Arup's calculated potentially savings is ~R207,091) could potentially be realised for 2022/2023 if the tariff is changed. The difference in the calculated savings is due to more variable costs considered by Arup. However, the savings determined are dependent on the plant's consumption pattern during the period as the Miniflex tariff is a TOU tariff.
